Inspection Report Minerals Regulatory Program November 15, 2011

Mine Name: Peat Humus	Permit Number: S0230058
Operator Name: Bonnie Birch Jensen	Inspection Date: November 10, 2011
Inspector(s): Wayne H. Western	Time: 12:30 – 1:30 PM
Other Participants: none	Mine Status: Inactive
Weather Conditions: 40's mostly sunny	Permit Fees: not paid
Bond Renewal Date: NA	Bond Amount: no bond

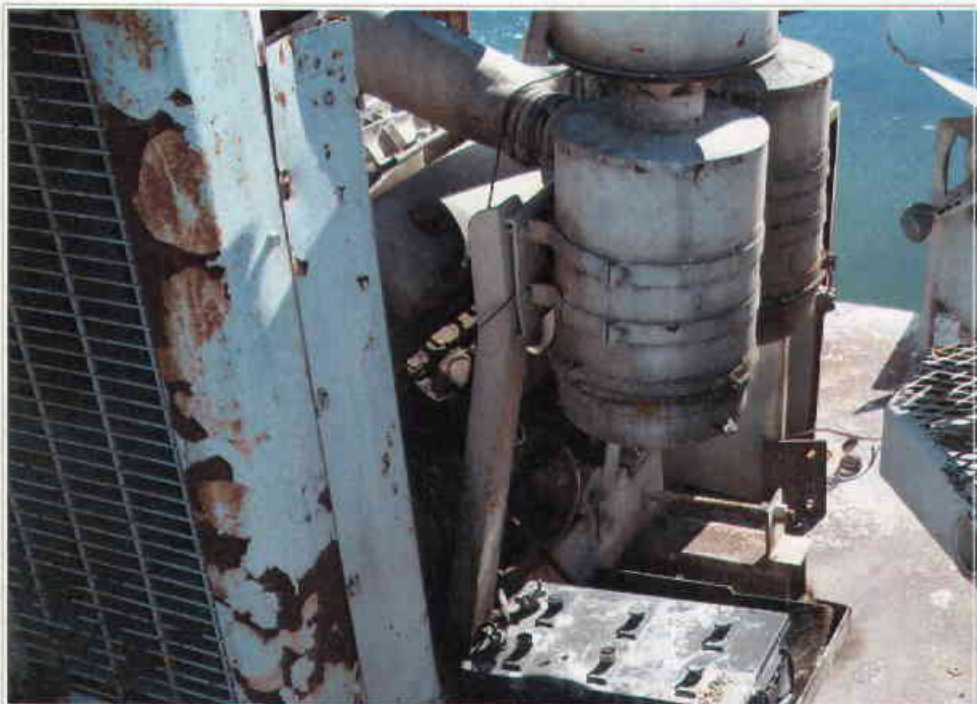
A battery was also on the barge. In addition there is a bucket of with unknown fluid in it. While things appeared stable there is the long range concern about what could happen to the petroleum products and battery acid.

Battery on barge

he Division should make a decision about doing the reclamation work on the site. The main concerns are removing fluids and other potential pollutants from the site.

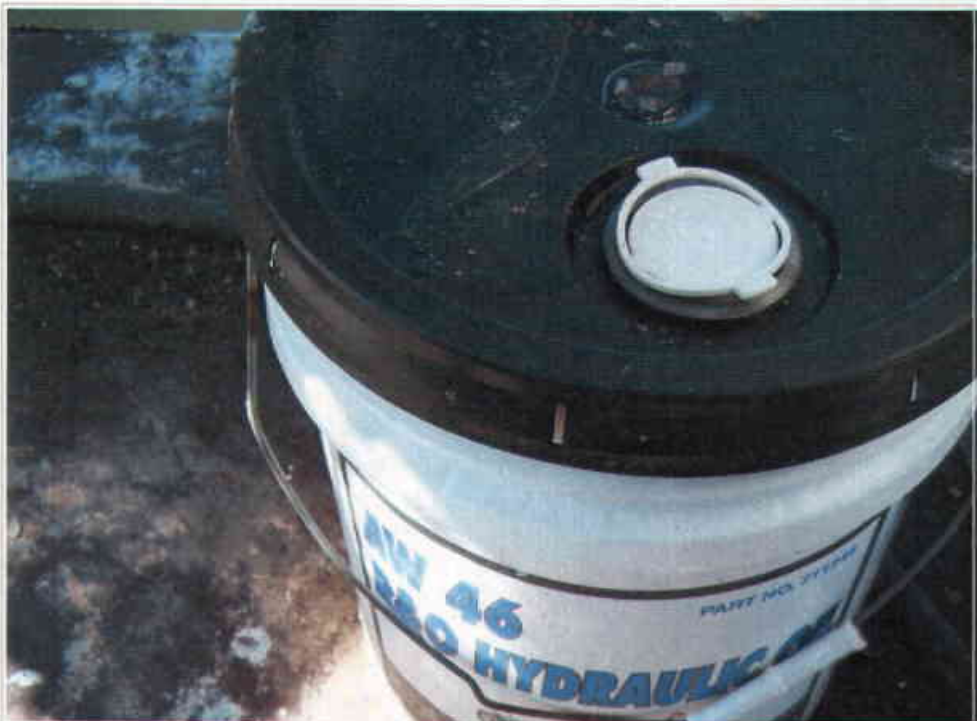
Bucket on barge

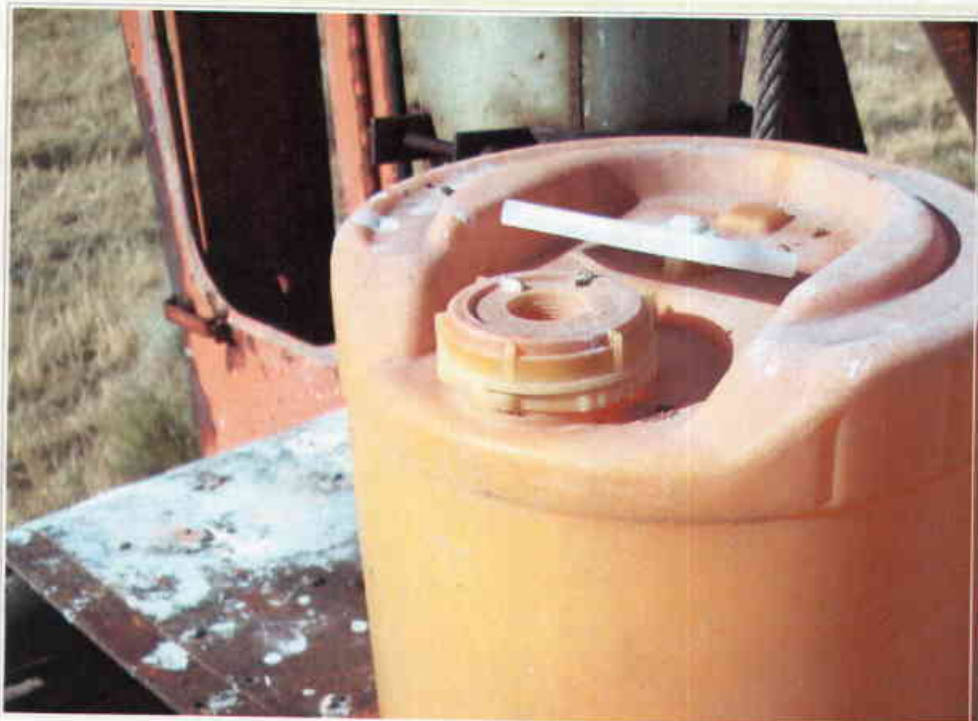
There a dragline on the site. On the right rear track there appears to be an oil stain. There is also a bucket with unknown fluid.

Bucket on dragline

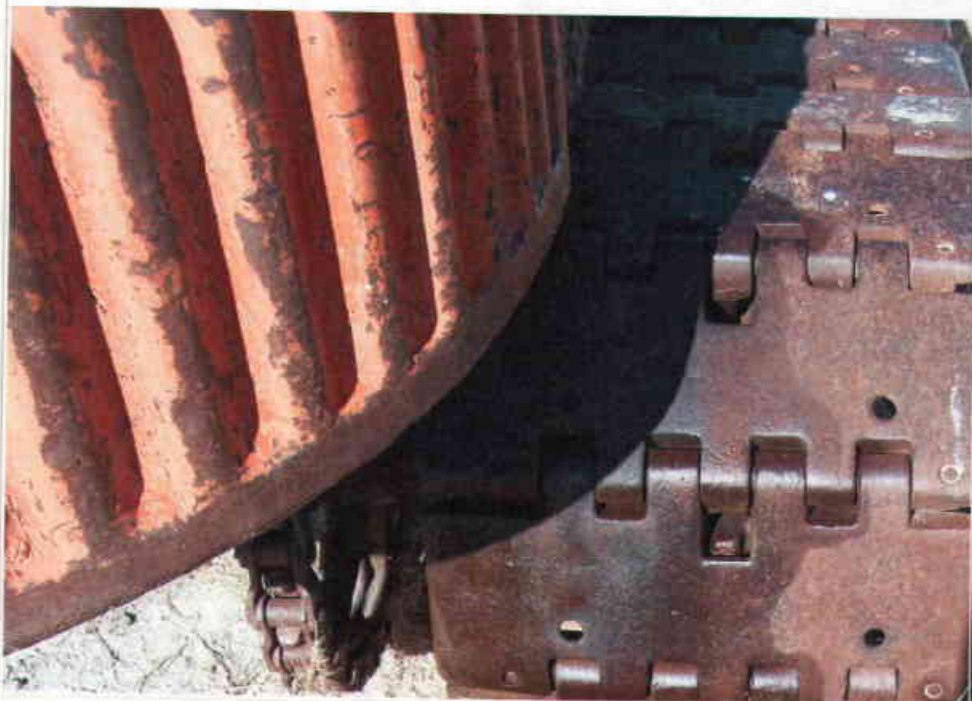
Oil stain on dragline track
